# Erfaringer med bruk av vanningsbom

Andreas Bakken  
Grinder Gård

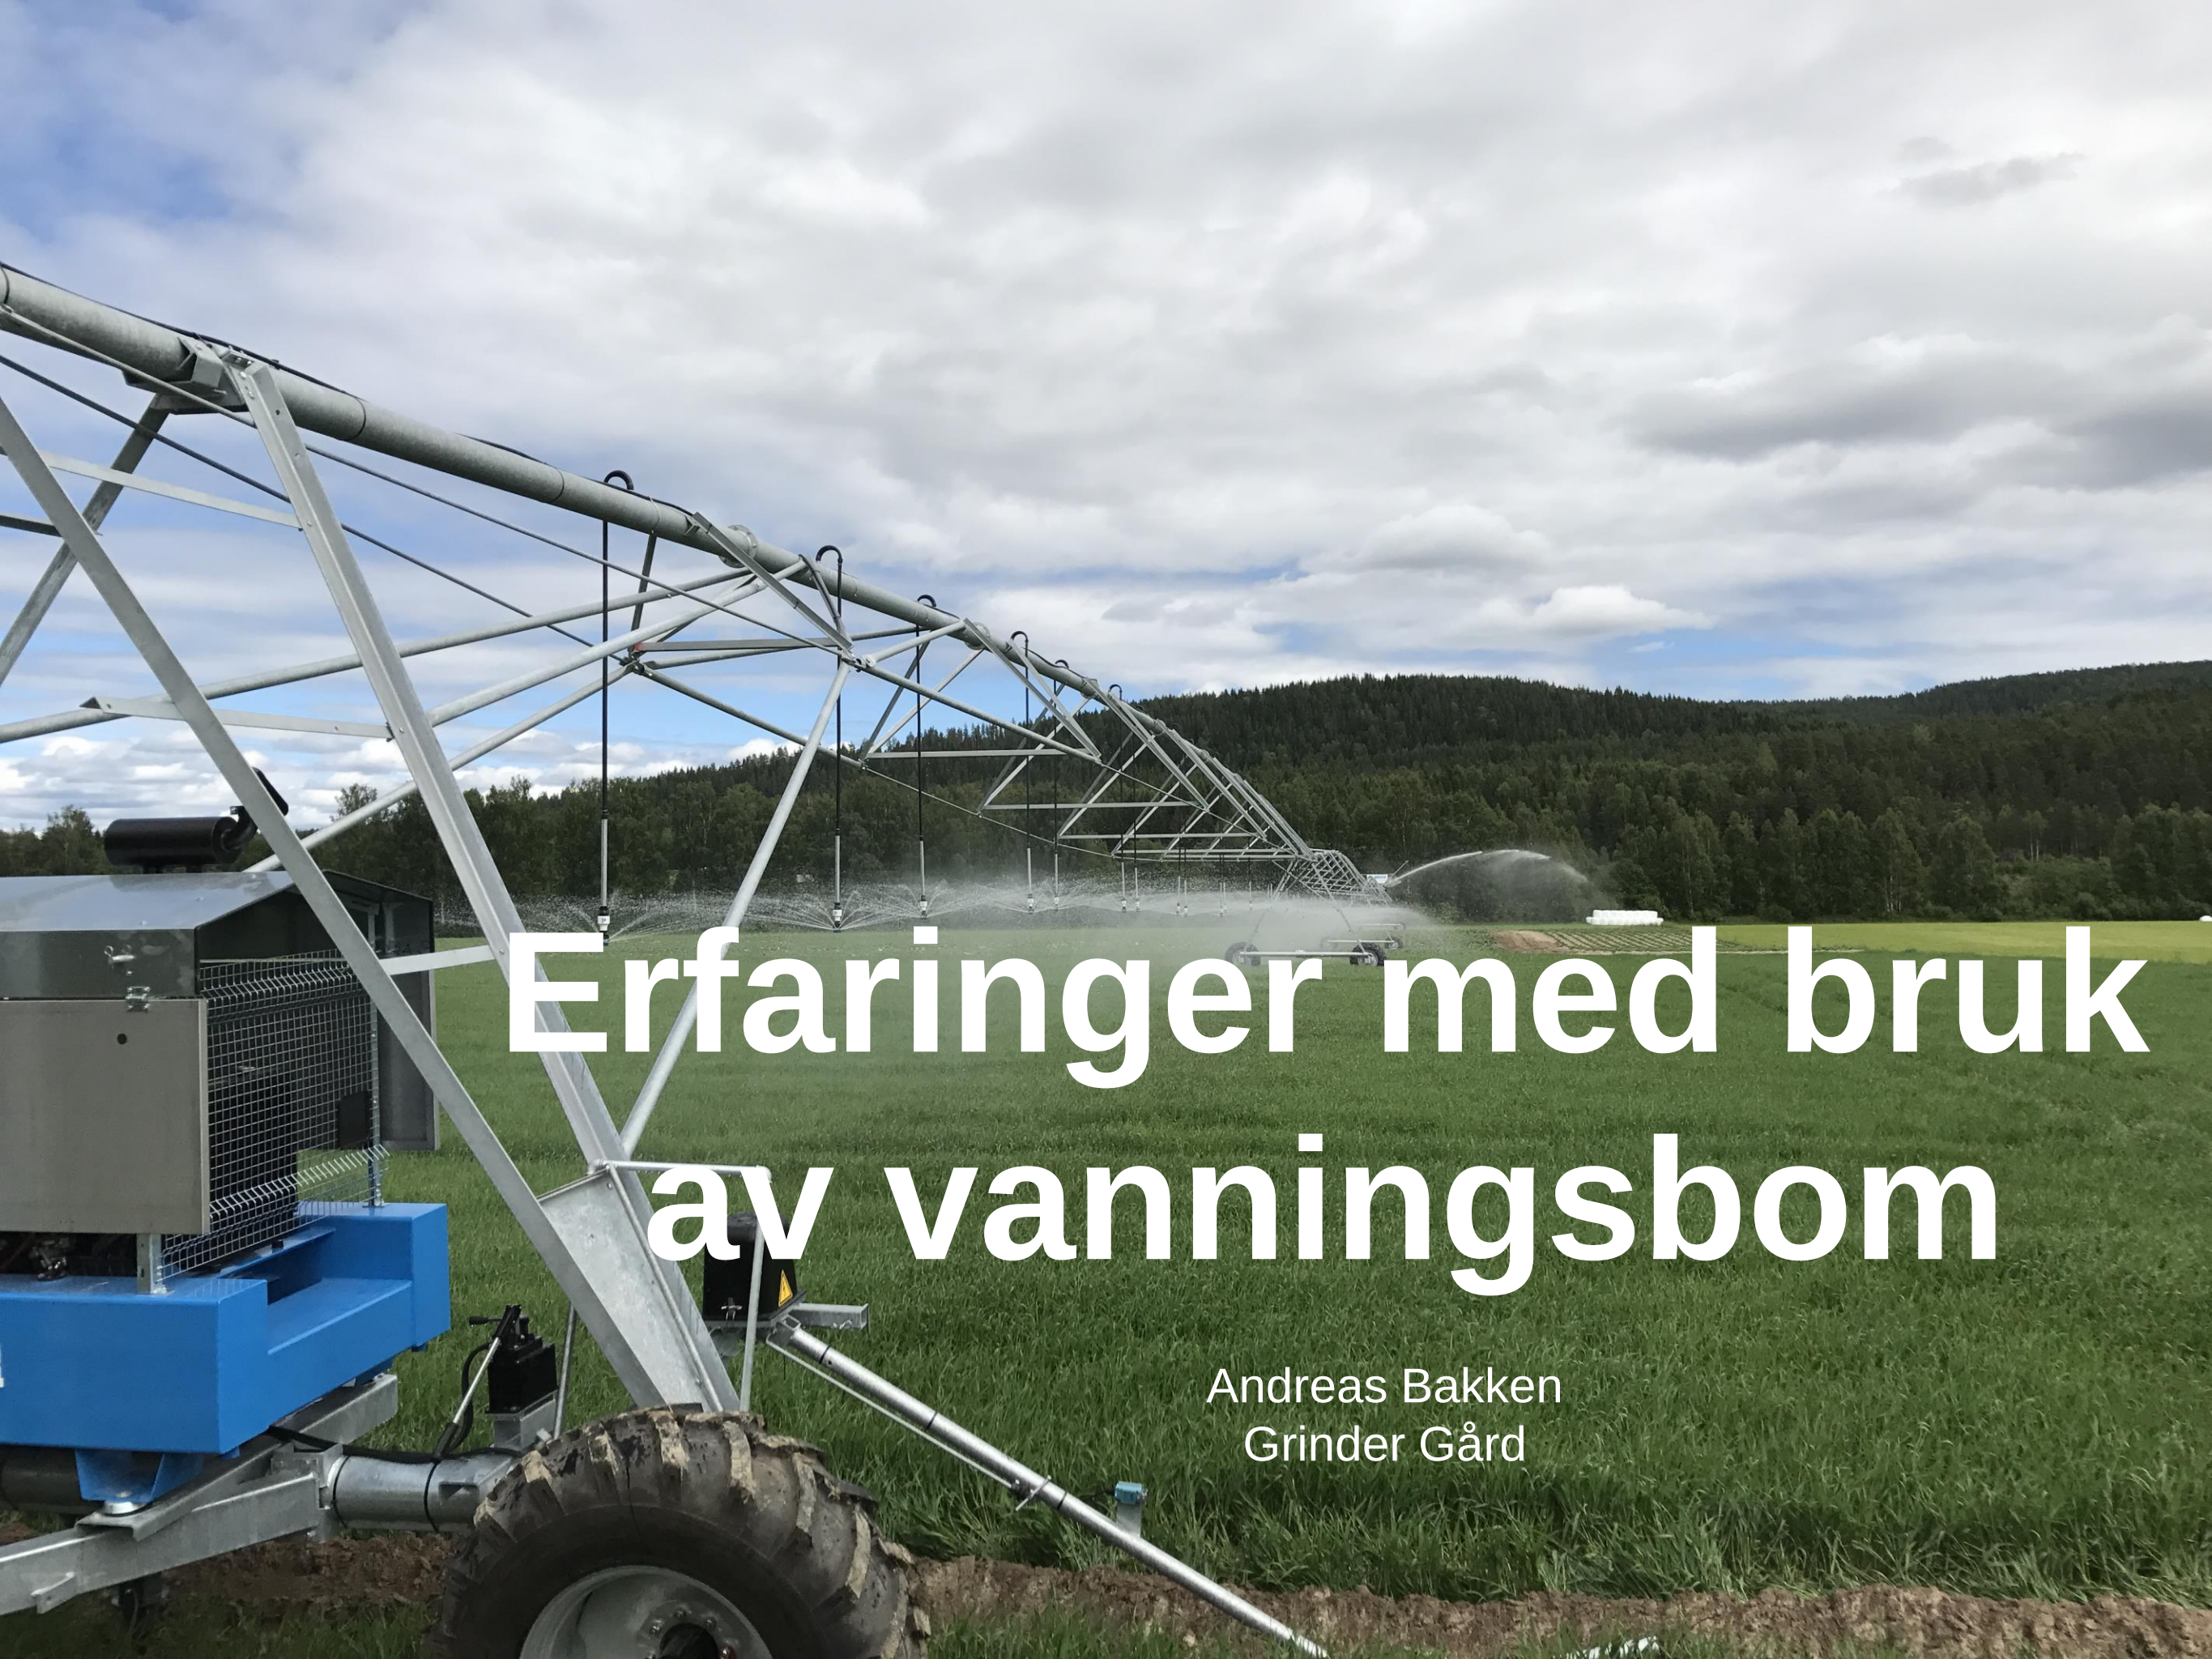
A large center pivot irrigation system is shown in a lush green field. The system consists of a long metal wheel line supported by a series of truss-like structures, with multiple lateral pipes and nozzles extending from it. Water is being sprayed from the nozzles onto the grass. In the foreground, a blue and silver control box is visible, mounted on a metal frame. A large, treaded tire is also visible in the lower left. The background features a dense forest of evergreen trees under a sky filled with white and grey clouds.

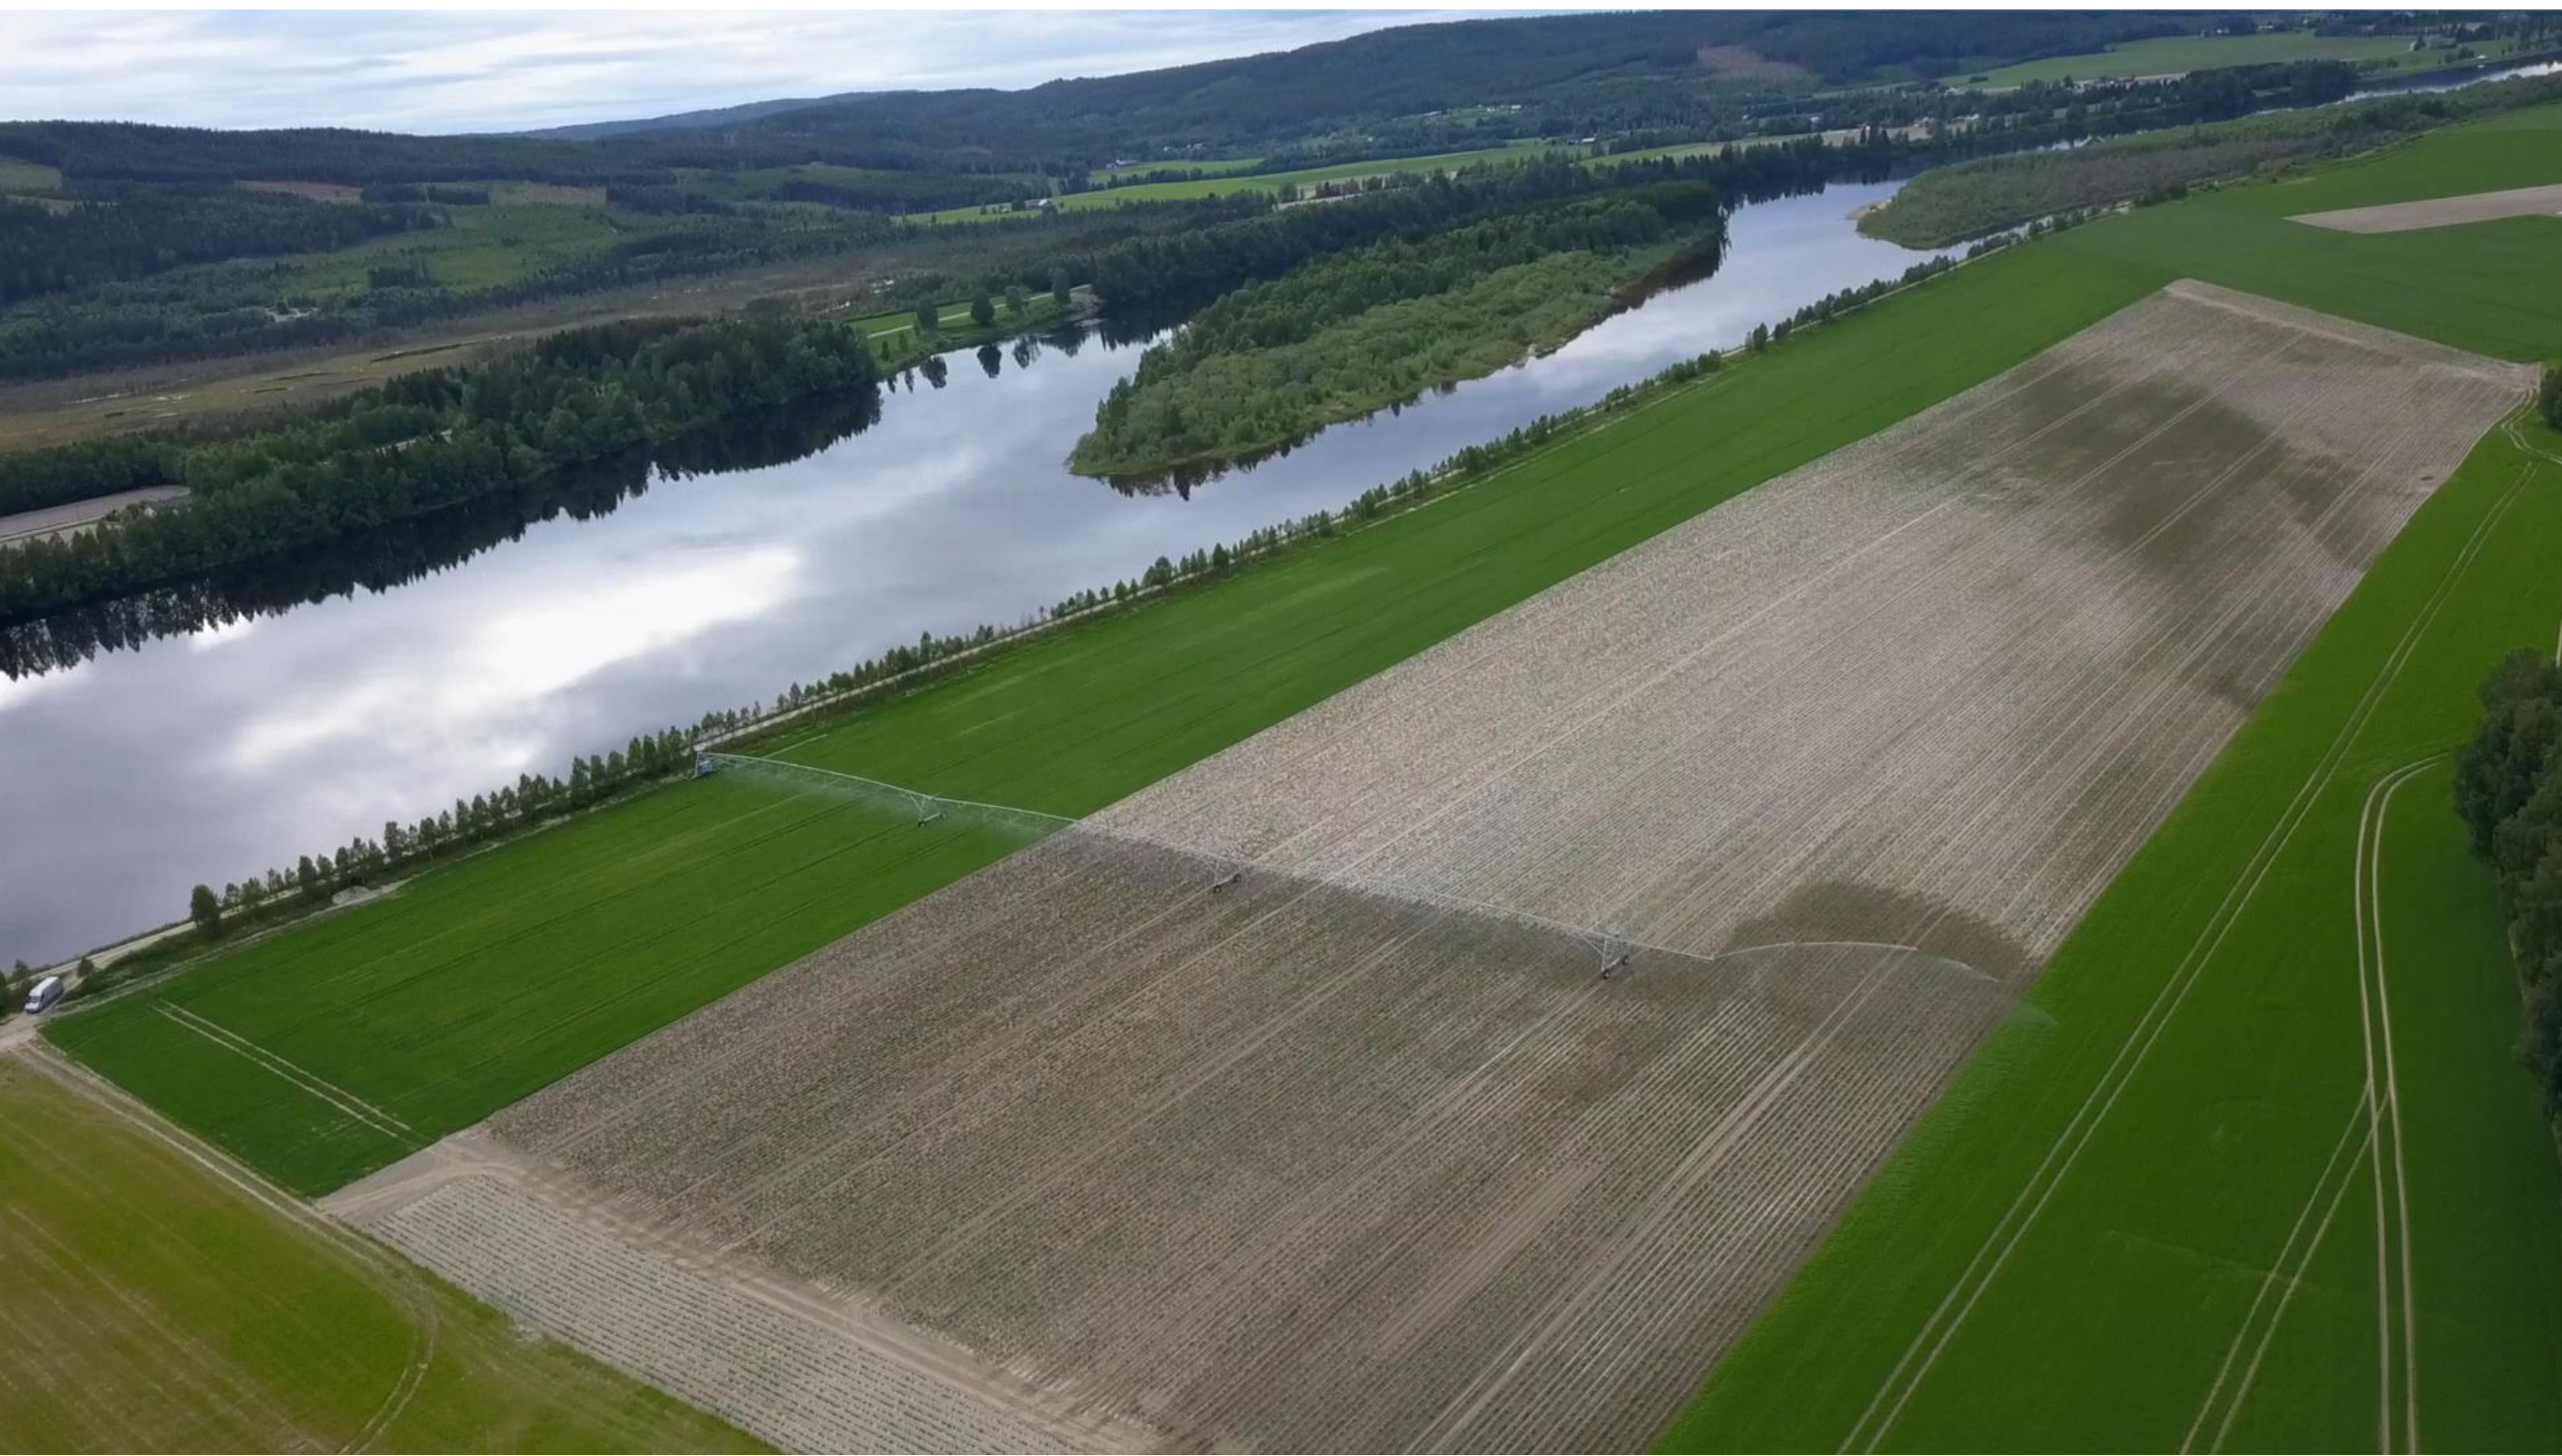
- 180 m lang, med kanon på enden ca 195m
- 1.800 m kjørevei
- Dekker ca. 390.da, hovedsakelig lett sandjord
